**Flood Control Project Maintenance  
Levee Inspections**

**Fall 2016 Levee Maintenance Deficiency Summary Report**

**Sacramento River Basin**

**Yolo County Service Area 6**

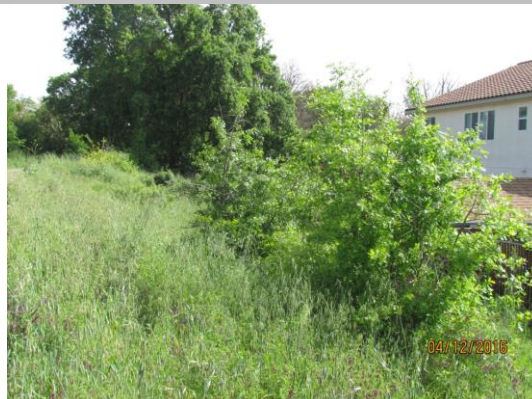
Photo 1 of 1 : FA\_2016\_NA0022\_350\_65\_20160913\_00046.jpg

LM Start	0.00	Rating **	M	Issue No.	65
LM End	0.20	Issue Type +	Ma	Location *	LS
Category	Earthen Levee			GPS Latitude/Longitude	
				Start	End
Item	Vegetation			38.799216 °	38.801317 °
				-121.724354 °	-121.722115 °
DWR ID	DWR_NA0022_01_s_2016_65				
Comment Code					
V2 : Remove the wild growth other than native grasses from the levee slopes.					
Inspector Comment					
Remove oak trees less than 4" in diamater at chest height on both sides of slope and trim trees.

View of the small oak trees on the landward side of the levee looking downstream. Spring 2016.

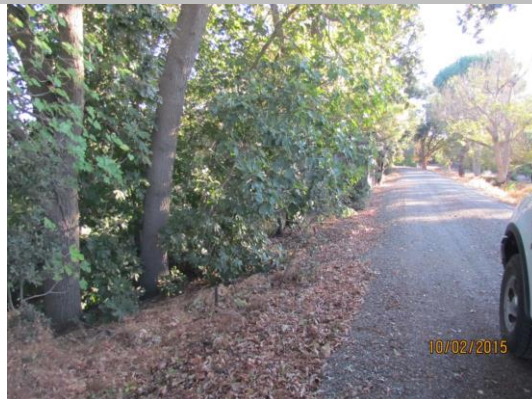
Photo 1 of 1 : FA\_2016\_NA0022\_350\_6\_20160913\_00007.jpg

LM Start	0.13	Rating **	M	Issue No.	6
LM End	0.20	Issue Type +	Ma	Location *	WS
Category	Earthen Levee			GPS Latitude/Longitude	
				Start	End
Item	Trim / Thin Trees			38.800645 °	38.801336 °
				-121.723172 °	-121.722106 °
DWR ID	DWR_NA0022_01_s_2012_6				
Comment Code					
T3 : Trim and thin trees to allow visibility of the ground and room to flood fight.					
Inspector Comment					
Trim trees to allow visibility.

View of the vegetation and trees on the waterward side of the levee looking downstream. Fall 2015.

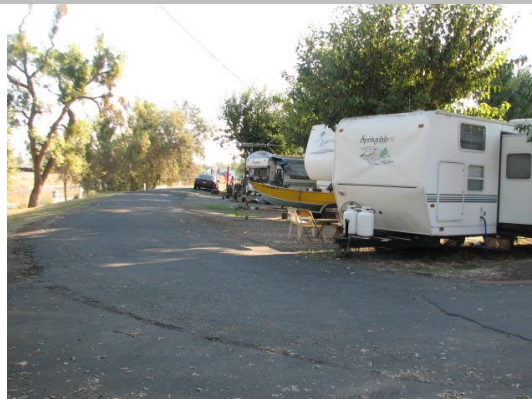
Photo 1 of 2 : FA\_2016\_NA0022\_350\_28\_20160913\_00026.jpg

LM Start	<b>0.22</b>	Rating **	M	Issue No.	<b>28 (cont)</b>
LM End	<b>0.25</b>	Issue Type +	En	Location *	LS

The RV park is encroached into the levee crown. Fall 2013

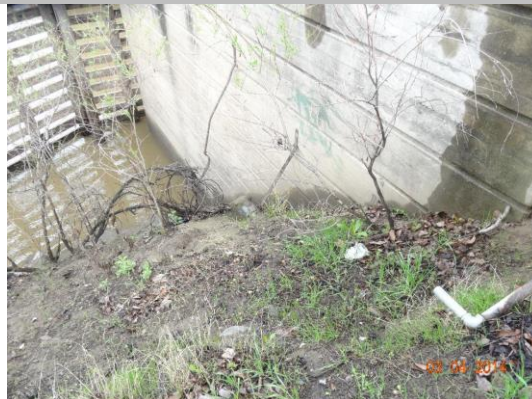
Photo 1 of 2 : UCIP\_FA\_2016\_31906\_58238.jpg

FS\_ID:31906  
DS\_ID:19534  
EP\_NO: 17016  
Repair Type: Non-Urgent  
Crossing Status: Indicator Found  
UCIP Comments: Unable to confirm crossing alignment--steel pipe visible on waterward side however, unable to confirm if crossing is the same one found during field confirmation. Need to contact owner to verify alignment and status of crossing. Slope was too steep to verify and obtain additional information about pipe.  
FIELD\_STRUCT\_DESC: Three 2-inch and three 1.5-inch fiber optic conduits through the levee, encased in a single high-density polyethylene (HDPE) conduit, 30-feet below the levee crown. Concrete caps on both ends of the casing, on the landside (LS) and waterside (WS). Voids in the HDPE conduit grouted. (Permit No. 17016, 2000 - Pacific Fiber Link, LLC).  
FS Date: 3/4/2014

Steel pipe located on waterward side--pipe disconnected.

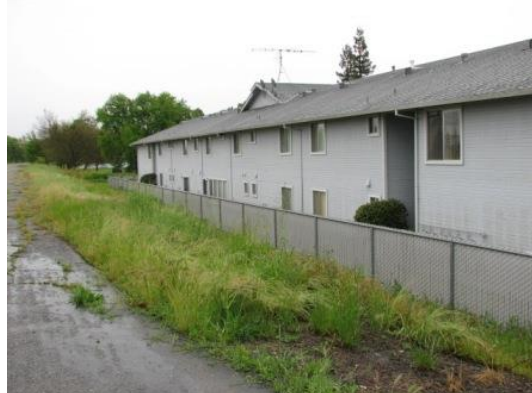
Photo 1 of 1 : FA\_2016\_NA0022\_350\_26\_20160913\_00023.jpg

LM Start	0.35	Rating **	M	Issue No.	26
LM End	0.39	Issue Type +	En	Location *	LS
Category	Earthen Levee			GPS Latitude/Longitude	
				Start	End
Item	Encroachments			38.801886 °	38.802020 °
				-121.719588 °	-121.718889 °
DWR ID	DWR_NA0022_01_s_2012_26				
Comment Code					
BU : Building					
Inspector Comment					
Apartments with chainlink fence with lathe woven into it.

The apartments and fence along the toe of the levee. Fall 2013

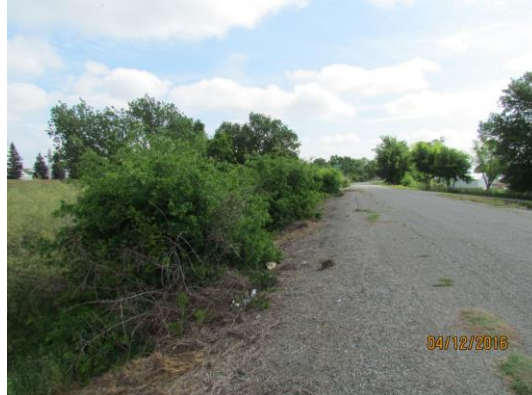
Photo 1 of 1 : FA\_2016\_NA0022\_350\_102\_20160913\_00069.jpg

LM Start	0.35	Rating **	M	Issue No.	102
LM End	0.48	Issue Type +	Ma	Location *	WS
Category	Earthen Levee			GPS Latitude/Longitude	
				Start	End
Item	Vegetation			38.801887°	38.802225°
				-121.719587°	-121.717186°
DWR ID	DWR_NA0022_01_s_2016_102				
Comment Code					
V2 : Remove the wild growth other than native grasses from the levee slopes.					
Inspector Comment					
Remove oak tree that is less than 4" at breast height.

View of the trees on the waterward side of the levee looking downstream. Spring 2016.

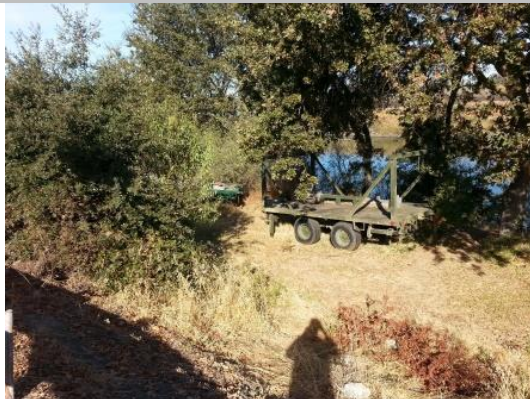
Photo 1 of 1 : FA\_2016\_NA0022\_350\_71\_20161010\_00150.jpg

LM Start	0.40	Rating **	M	Issue No.	71
LM End	0.40	Issue Type +	En	Location *	WS
Category	Earthen Levee			GPS Latitude/Longitude	
				Start	End
Item	Encroachments			38.802052 °	38.802052 °
				-121.718624 °	-121.718624 °
DWR ID	DWR_NA0022_01_f_2016_71				
Comment Code					
EQ : Equipment					
Inspector Comment

Vehicles and equipment on waterward side of the levee. Fall inspection 10/07/2016.

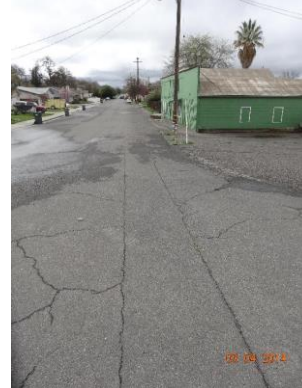
Photo 1 of 2 : UCIP\_FA\_2016\_31627\_57881.jpg

LM Start	0.51	Rating **	M	Issue No.	406
LM End	0.51	Issue Type +	En	Location *	WS
Category	Supplemental			GPS Latitude/Longitude	
				Start	End
Item	DWR UCIP Field Study			38.802062 °	38.802062 °
				-121.716740 °	-121.716740 °
DWR ID					
Comment Code					
Inspector Comment					
FS_ID:31627 DS_ID:19544 EP_NO: N/A Repair Type: Non-Urgent Crossing Status: Indicator Found UCIP Comments: Unable to confirm if signs of crossing are for the same crossing listed here. Need to contact owner and determine additional information about crossing. Also found is service box for water line--need permit and alignment confirmation. FIELD_STRUCT_DESC: 10-inch steel pipe through the levee at an unknown depth below the crown. [Additional Reference(s): DWR Levee Log, 1990 and 2005. USACE Sacramento O&M Manual Unit No. 127, June 1953, (Station 285+27)]. FS Date: 3/4/2014

View of landward side. Alignment is visible on paved road.

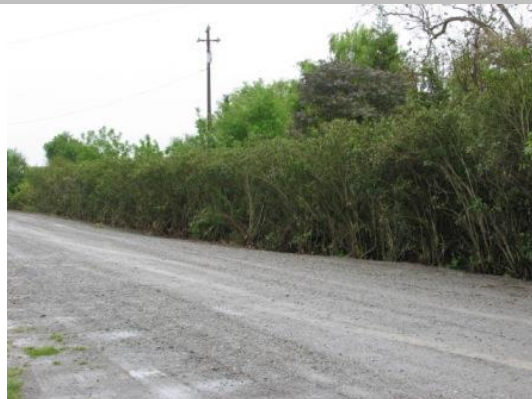
Photo 1 of 1 : FA\_2016\_NA0022\_350\_22\_20160913\_00019.jpg

LM Start	0.57	Rating **	U	Issue No.	22
LM End	0.92	Issue Type +	En	Location *	LS
Category	Earthen Levee			GPS Latitude/Longitude	
				Start	End
Item	Vegetation			38.801815 °	38.800208 °
				-121.715628 °	-121.709437 °
DWR ID	DWR_NA0022_01_s_2012_22				
Comment Code					
V6 : Landscaping					
Inspector Comment					
Oleander hedge

Oleanders along the shoulder.

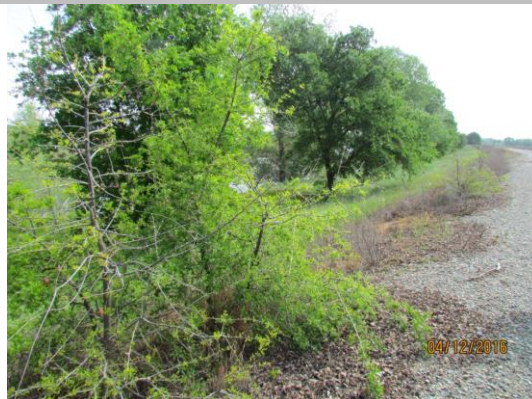
Photo 1 of 1 : FA\_2016\_NA0022\_350\_106\_20160913\_00071.jpg

LM Start	0.70	Rating **	M	Issue No.	106
LM End	0.70	Issue Type +	Ma	Location *	WS
Category	Earthen Levee			GPS Latitude/Longitude	
				Start	End
Item	Vegetation			38.801059 °	38.801059 °
				-121.713373 °	-121.713373 °
DWR ID	DWR_NA0022_01_s_2016_106				
Comment Code					
V2 : Remove the wild growth other than native grasses from the levee slopes.					
Inspector Comment					
Remove oak tree less than 4" at chest height that is within 20' of waterside shoulder.

View of the small tree on the waterward side of the levee looking downstream. Spring 2016.

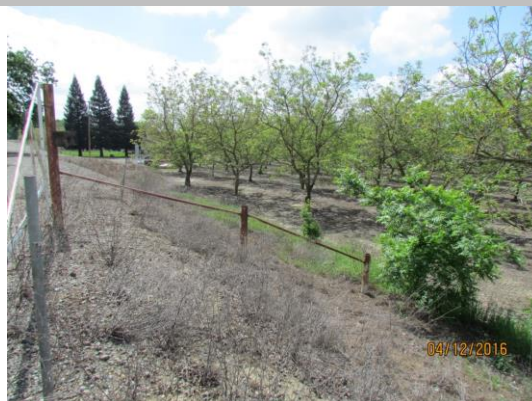
Photo 1 of 1 : FA\_2016\_NA0022\_350\_112\_20160913\_00073.jpg

LM Start	1.77	Rating **	M	Issue No.	112
LM End	1.77	Issue Type +	Ma	Location *	LS
Category	Earthen Levee			GPS Latitude/Longitude	
				Start	End
Item	Vegetation			38.797596 °	38.797596 °
				-121.697855 °	-121.697855 °
DWR ID	DWR_NA0022_01_s_2016_112				
Comment Code					
V2 : Remove the wild growth other than native grasses from the levee slopes.					
Inspector Comment					
Remove walnut and oak tree at landside toe that is less than 4" in diameter at breast height.

View of the tree at the toe of the levee on the landward side looking downstream. Spring 2016.

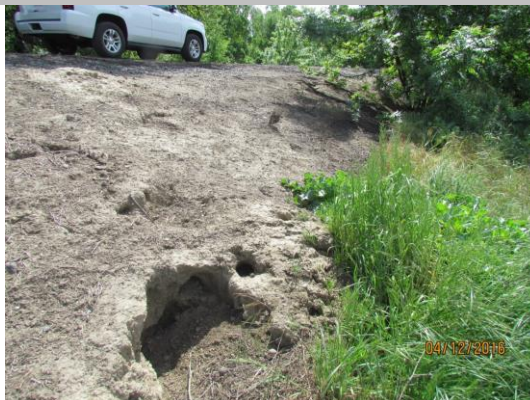
Photo 1 of 1 : FA\_2016\_NA0022\_350\_119\_20160913\_00075.jpg

LM Start	1.96	Rating **	U	Issue No.	119
LM End	1.96	Issue Type +	Ma	Location *	LS
Category	Earthen Levee			GPS Latitude/Longitude	
				Start	End
Item	Animal Control			38.795418 °	38.795418 °
				-121.695964 °	-121.695964 °
DWR ID	DWR_NA0022_01_s_2016_119				
Comment Code					
A3 : No rodents visible, but rodent burrows visible; need to backfill and compact or grout burrows.					
Inspector Comment

View of the rodent hole on the landward side of the levee. Spring 2016.

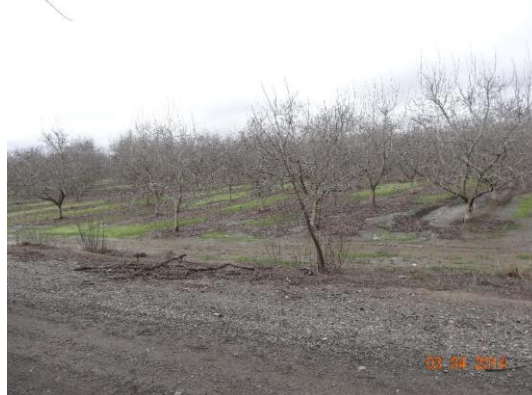
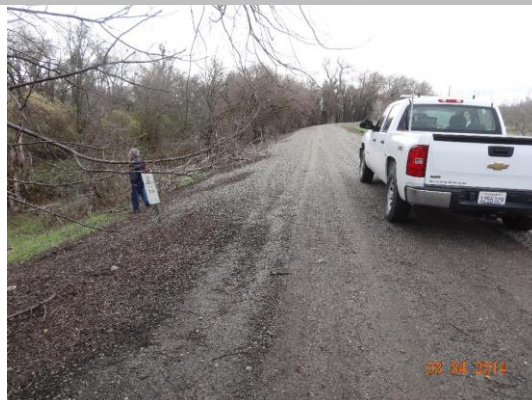
LM Start	<b>1.97</b>	Rating **	M	Issue No.	<b>411 (cont)</b>
LM End	<b>1.97</b>	Issue Type +	En	Location *	LS

View of landward side.

View of levee crown at crossing.

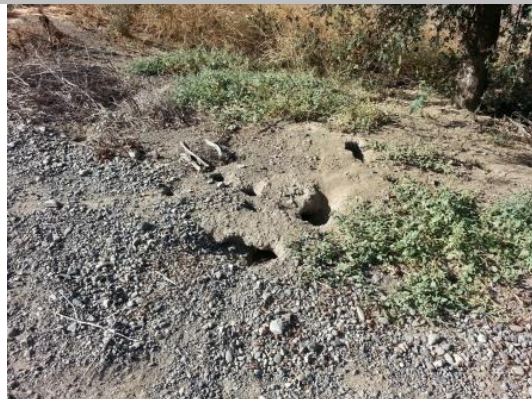
Photo 1 of 1 : FA\_2016\_NA0022\_350\_117\_20161010\_00152.jpg

LM Start	1.97	Rating **	M	Issue No.	117
LM End	2.06	Issue Type +	Ma	Location *	LS
Category	Earthen Levee			GPS Latitude/Longitude	
				Start	End
Item	Animal Control			38.795234 °	38.793974 °
				-121.695898 °	-121.695852 °
DWR ID	DWR_NA0022_01_s_2016_117				
Comment Code					
A3 : No rodents visible, but rodent burrows visible; need to backfill and compact or grout burrows.					
Inspector Comment

Series of animal burrows on LS slope of the levee. Fall inspection 10/07/2016.

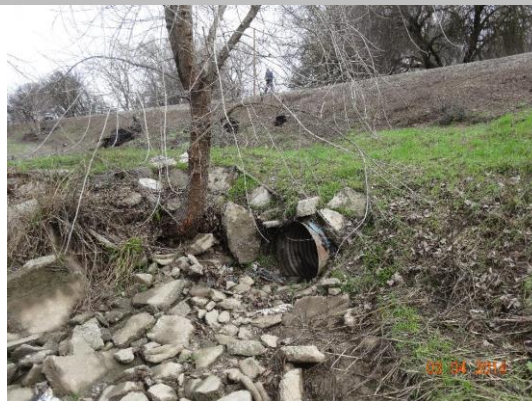
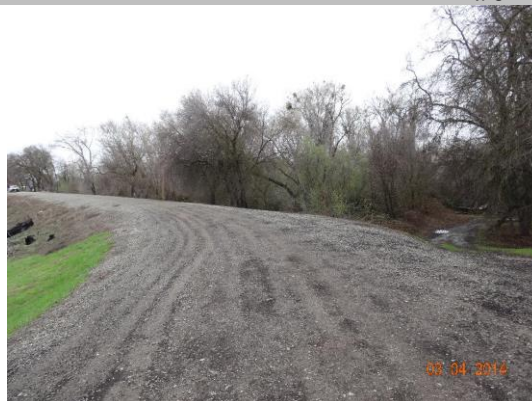
LM Start	<b>2.04</b>	Rating **	M	Issue No.	<b>407 (cont)</b>
LM End	<b>2.04</b>	Issue Type +	En	Location *	WS

Outlet located on landward toe.

Overview of levee crown at crossing.

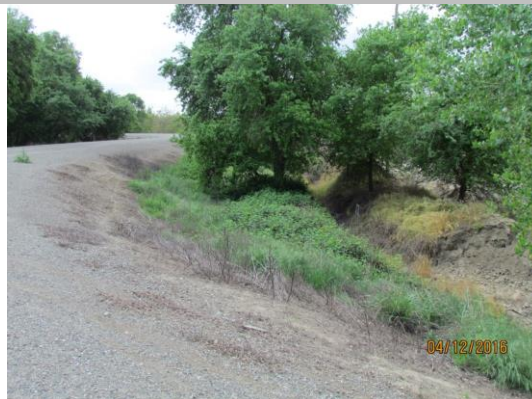
Photo 1 of 1 : FA\_2016\_NA0022\_350\_7\_20160913\_00008.jpg

LM Start	2.04	Rating **	M	Issue No.	7
LM End	2.14	Issue Type +	En	Location *	LS
Category	Earthen Levee			GPS Latitude/Longitude	
				Start	End
Item	Encroachments			38.794259 °	38.792907 °
				-121.695697 °	-121.696033 °
DWR ID	DWR_NA0022_01_s_ 2016_7				
Comment Code					
DT : Ditch					
Inspector Comment					
Ditch is at the toe of the levee.

View of the ditch at the levee toe on the landward side looking downstream. Spring 2016.

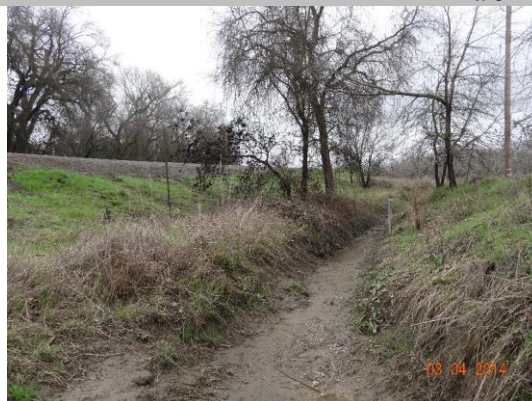
Photo 2 of 2 : UCIP\_FA\_2016\_31915\_58269.jpg

Comment Code					
Inspector Comment					
FS_ID:31915 DS_ID:19538 EP_NO: N/A Repair Type: Non-Urgent Crossing Status: Indicator Found UCIP Comments: Buried gate valve on landward slope. Crossing appears to be non-functional. Landward pipe section across canal has deteriorated. Will need to contact owner to determine status of crossing. If crossing is not in use owner will need to contact the CVFPB to abandon properly according to Title 23. FIELD_STRUCT_DESC: 20-inch corrugated metal drain pipe through the levee at an unknown depth. 20-inch gate valve is located on the landside (LS) slope. [Additional Reference(s): USACE Sacramento O&M Manual Unit No. 127, June 1953, (Station 208+15)]. This crossing could be the same record as DS_ID 19524--unable to confirm. FS Date: 3/4/2014

View of canal runs parallel on landward toe.

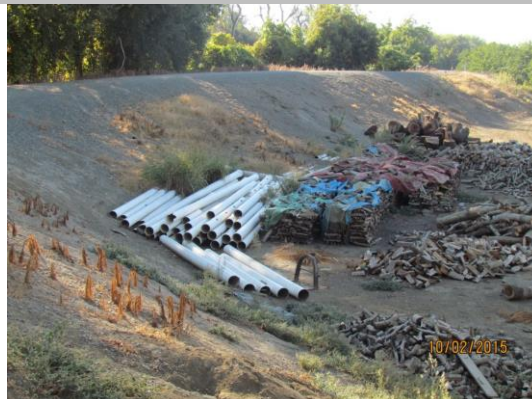
Photo 2 of 2 : FA\_2016\_NA0022\_350\_40\_20160913\_00036.jpg

LM Start	2.18	Rating **	M	Issue No.	40 (cont)	
LM End	2.18	Issue Type +	En	Location *	LS	
Category	Earthen Levee			GPS Latitude/Longitude		
				Start		End
Item	Encroachments			38.792499 °		38.792499 °
				-121.695508 °		-121.695508 °
DWR ID	DWR_NA0022_01_s_2012_40					
Comment Code						
EQ : Equipment						
Inspector Comment						
Equipment is placed at the toe of the levee.

View of equipment on the landward side of the levee looking downstream. Fall 2015.

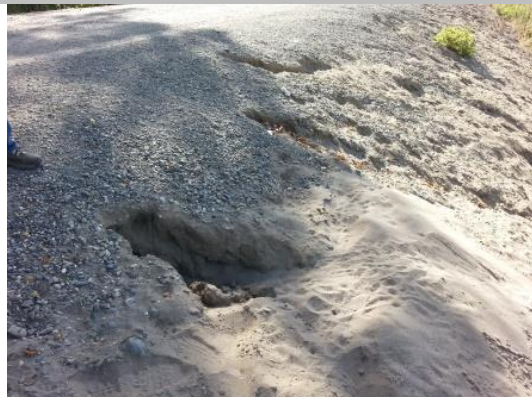
Photo 1 of 2 : FA\_2016\_NA0022\_350\_93\_20161010\_00157.jpg

LM Start	<b>2.21</b>	Rating **	M	Issue No.	<b>93 (cont)</b>
LM End	<b>2.21</b>	Issue Type +	Ma	Location *	LS

Slope stability issue in LS slope of the levee. Fall inspection 10/07/2016.

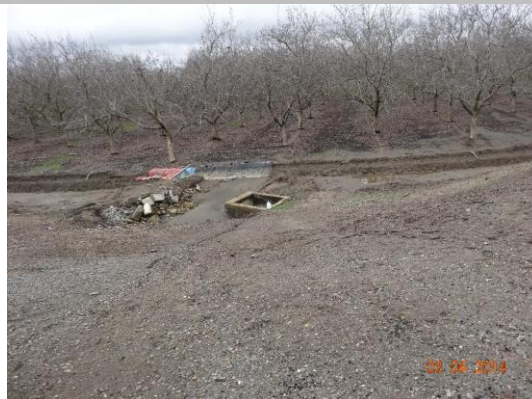
Photo 1 of 2 : UCIP\_FA\_2016\_49982\_57915.jpg

View of LS toe.

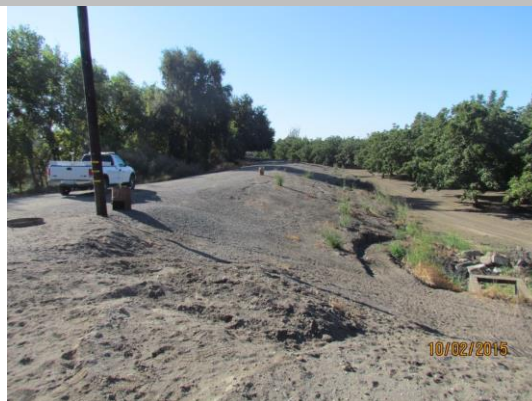
Photo 1 of 3 : FA\_2016\_NA0022\_350\_96\_20160913\_00065.jpg

LM Start	<b>2.35</b>	Rating **	M	Issue No.	<b>96 (cont)</b>
LM End	<b>2.35</b>	Issue Type +	Ma	Location *	LS

Perspective view of the erosion around the pipe on the landward side of the levee looking downstream. Fall 2015.

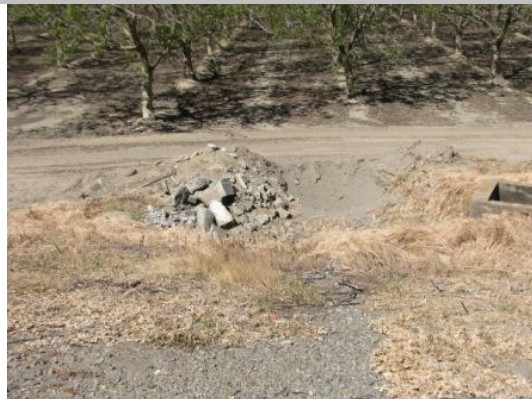
Photo 1 of 1 : FA\_2016\_NA0022\_350\_45\_20160913\_00040.jpg

LM Start	2.35	Rating **	M	Issue No.	45
LM End	2.35	Issue Type +	En	Location *	LS
Category	Earthen Levee			GPS Latitude/Longitude	
				Start	End
Item	Encroachments			38.790180 °	38.790180 °
				-121.694525 °	-121.694525 °
DWR ID	DWR_NA0022_01_s_2013_45				
Comment Code					
DE : Debris					
Inspector Comment

Concrete debris is at the toe of the levee. Spring 2013

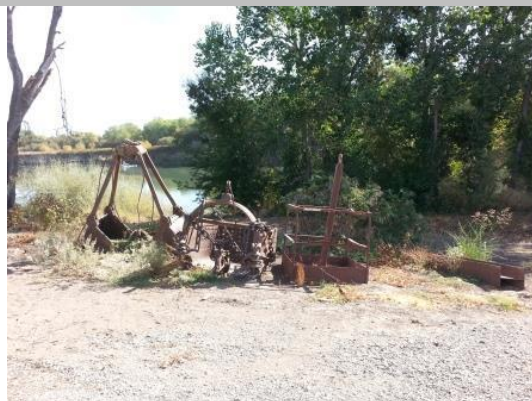
Photo 1 of 1 : FA\_2016\_NA0022\_350\_97\_20161010\_00161.jpg

LM Start	2.35	Rating **	M	Issue No.	97
LM End	2.35	Issue Type +	En	Location *	WS
Category	Earthen Levee			GPS Latitude/Longitude	
				Start	End
Item	Encroachments			38.790175 °	38.790175 °
				-121.694519 °	-121.694519 °
DWR ID	DWR_NA0022_01_f_2016_97				
Comment Code					
EQ : Equipment					
Inspector Comment

Equipment on waterside slope. Fall inspection 10/07/2016.

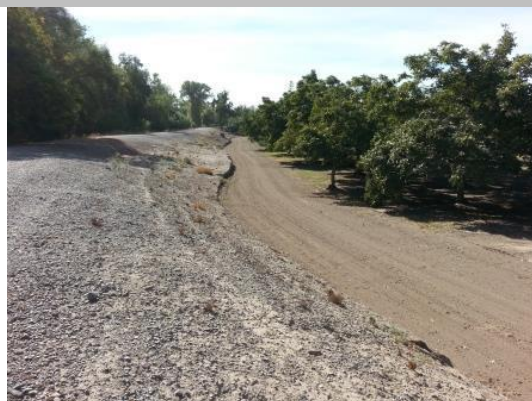
Photo 1 of 2 : FA\_2016\_NA0022\_350\_94\_20161010\_00162.jpg

LM Start	2.41	Rating **	M	Issue No.	94
LM End	2.55	Issue Type +	En	Location *	LS
Category	Earthen Levee			GPS Latitude/Longitude	
				Start	End
Item	Encroachments			38.789382 °	38.787405 °
				-121.694584 °	-121.694283 °
DWR ID	DWR_NA0022_01_s_2016_94				
Comment Code					
AT : Agricultural tilling					
Inspector Comment					
Monitor cut at the toe of the levee.

An updated view of the site where landside slope was tilled due to agricultural activity. Fall inspection 10/07/2016.

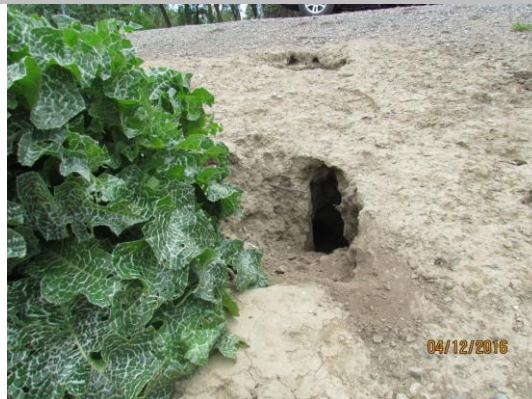
Photo 1 of 2 : FA\_2016\_NA0022\_350\_123\_20160913\_00077.jpg

LM Start	2.52	Rating **	U	Issue No.	123
LM End	2.52	Issue Type +	Ma	Location *	LS
Category	Earthen Levee			GPS Latitude/Longitude	
				Start	End
Item	Animal Control			38.787768 °	38.787768 °
				-121.694295 °	-121.694295 °
DWR ID	DWR_NA0022_01_s_2016_123				
Comment Code					
A3 : No rodents visible, but rodent burrows visible; need to backfill and compact or grout burrows.					
Inspector Comment

View of the rodent hole next to a tree stump on the landward side of the levee. Spring 2016.

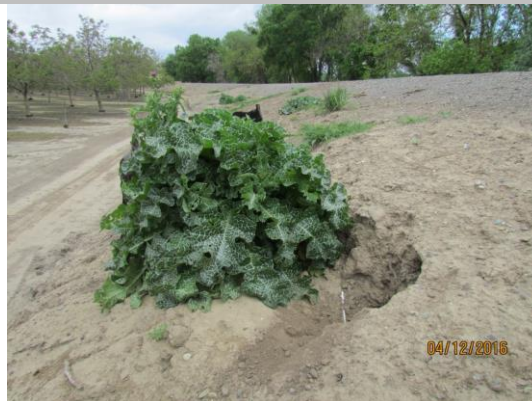
Photo 2 of 2 : FA\_2016\_NA0022\_350\_123\_20160913\_00078.jpg

LM Start	<b>2.52</b>	Rating **	U	Issue No.	<b>123 (cont)</b>
LM End	<b>2.52</b>	Issue Type +	Ma	Location *	LS

Perspective view of the rodent hole looking upstream. Spring 2016.

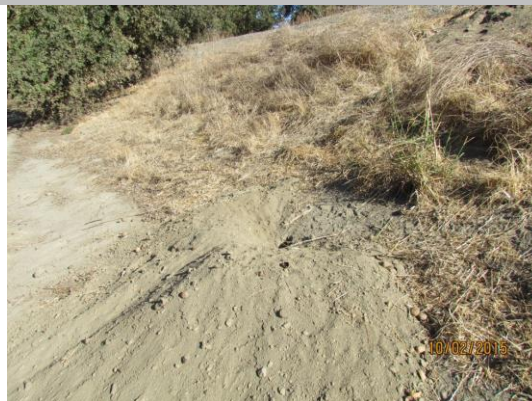
Photo 1 of 2 : FA\_2016\_NA0022\_350\_52\_20160913\_00044.jpg

LM Start	2.87	Rating **	U	Issue No.	52
LM End	2.92	Issue Type +	Ma	Location *	LS
Category	Earthen Levee			GPS Latitude/Longitude	
				Start	End
Item	Animal Control			38.783571 °	38.783021 °
				-121.692110 °	-121.691633 °
DWR ID	DWR_NA0022_01_f_2013_52				
Comment Code					
A1 : Exterminate rodents and backfill and compact or grout burrows.					
Inspector Comment

View of the rodent hole and material on the landward side of the levee.  
Fall 2015.

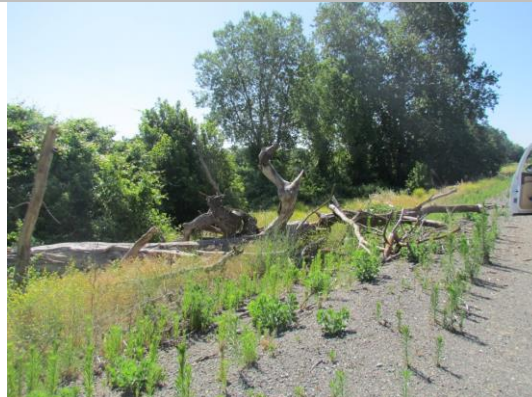
Photo 1 of 2 : FA\_2016\_NA0022\_350\_47\_20160913\_00042.jpg

LM Start	<b>3.14</b>	Rating **	M	Issue No.	<b>47 (cont)</b>
LM End	<b>3.14</b>	Issue Type +	En	Location *	WS

View of the fallen tree on the waterward side of the levee looking downstream. Spring 2015.

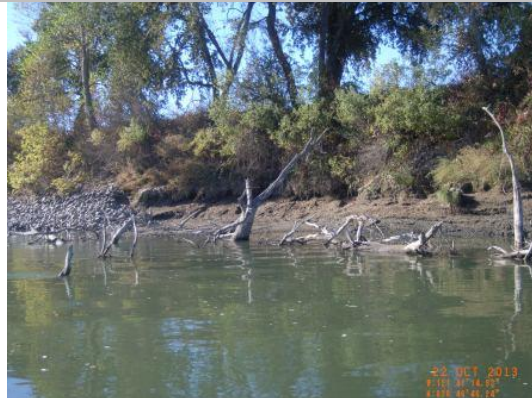
Photo 1 of 1 : FA\_2016\_NA0022\_350\_5\_20160913\_00006.jpg

LM Start	3.18	Rating **	M	Issue No.	5
LM End	3.28	Issue Type +	Ma	Location *	WS
Category	Supplemental			GPS Latitude/Longitude	
				Start	End
Item	2015 USACE Erosion Survey, DRAFT			38.780407 °	38.779137 °
				-121.688238 °	-121.687432 °
DWR ID	DWR_NA0022_01_s_2016_5				
Comment Code					
Inspector Comment					
2006 - Short section is into the levee toe, rest is near the levee toe. Mass failure and fluvial erosion of depositional material. Rock at the upstream and downstream ends. 2011 - Minor new erosion. 2012 - Slope continues to steepen, tree roots have become exposed, and new eddy formed. 2015: No observed changes. [2015 Site ID: SAC 86-9 R]

USACE 2013 Photo #1

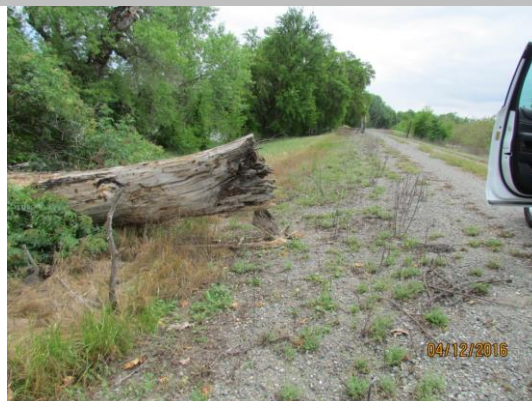
Photo 1 of 1 : FA\_2016\_NA0022\_350\_15\_20160913\_00015.jpg

LM Start	3.20	Rating **	M	Issue No.	15
LM End	3.20	Issue Type +	Ma	Location *	WS
Category	Earthen Levee			GPS Latitude/Longitude	
				Start	End
Item	Encroachments			38.779971 °	38.779971 °
				-121.688490 °	-121.688490 °
DWR ID	DWR_NA0022_01_s_2016_15				
Comment Code					
TR : Tree or limb					
Inspector Comment

View of the fallen tree on the waterward slope of the levee looking downstream. Spring 2016.

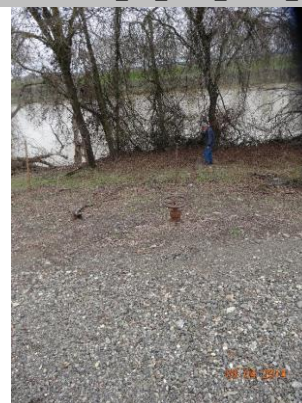
Photo 1 of 2 : UCIP\_FA\_2016\_39858\_71841.jpg

LM Start	3.23	Rating **	M	Issue No.	415
LM End	3.23	Issue Type +	En	Location *	WS
Category	Supplemental			GPS Latitude/Longitude	
				Start	End
Item	DWR UCIP Field Study			38.779625 °	38.779625 °
				-121.688090 °	-121.688090 °
DWR ID					
Comment Code					
Inspector Comment

View of waterward side.

FS\_ID:39858  
DS\_ID:19526  
EP\_NO: 3205  
Repair Type: Non-Urgent  
Crossing Status: Found  
UCIP Comments: Need to contact owner to determine status of crossing. If crossing is no longer used need to coordinate with CVFPB for proper abandonment.  
FIELD\_STRUCT\_DESC: 12-inch irrigation pipe of unknown material through the levee, 4 feet below the crown. Pump is located on the waterside (WS). Gate valve is located on the WS slope. Siphon breaker is located inside an 18-inch concrete riser located on the landside (LS) slope. 36-inch concrete standpipe is located at toe of LS slope. Metal cutoff wall installed. Permit No. 3205 was issued in 1959 for the removal of an existing 12-inch pipe (USACE O&M Station Station 144+80) and re-installment of a 12-inch pipe. (Permit No. 3205, 1959 - Richardson) [Additional Reference(s): DWR Levee Log, 1955, 1990, and 2005. USACE Sacramento O&M Manual Unit No. 127, June 1953, (Station 144+80)].

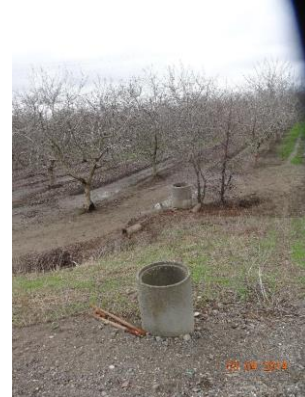
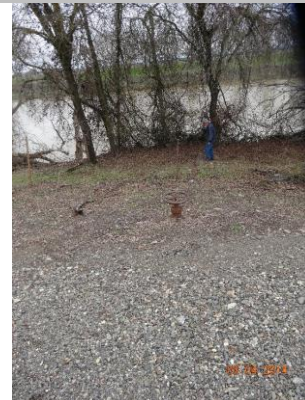
Comment Code					
Inspector Comment					
FS_ID:31916 DS_ID:19545 EP_NO: N/A Repair Type: Non-Urgent Crossing Status: Indicator Found UCIP Comments: Need to contact owner--Crossing appears to be abandoned. If crossing is no longer in use, crossing need to be abandoned properly per Title 23. FIELD_STRUCT_DESC: *REMOVED* 12-inch steel irrigation pipe through the levee. Pump is located on the waterside (WS). Concrete standpipe is located on the landside (LS). Permit No. 3205 was issued in 1959 for the removal of an existing 12-inch pipe (USACE O&M Station Station 144+80) and re-installment of a new 12-inch pipe. [Additional Reference(s): USACE Sacramento O&M Manuals: Unit No. 127, June 1953, (Station 144+80)]. FS Date: 3/4/2014

View of landward side.

View of waterward side.

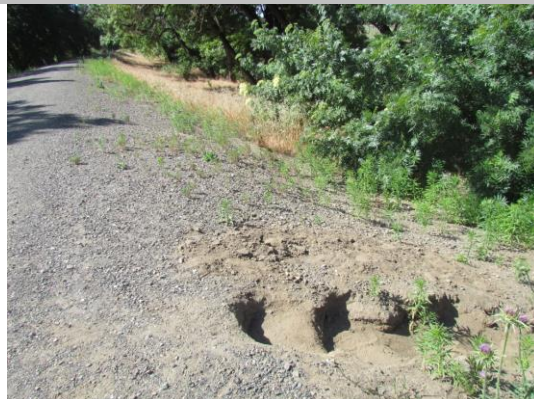
Photo 1 of 3 : FA\_2016\_NA0022\_350\_79\_20160913\_00053.jpg

LM Start	3.41	Rating **	M	Issue No.	79
LM End	3.41	Issue Type +	Ma	Location *	LS
Category	Earthen Levee			GPS Latitude/Longitude	
				Start	End
Item	Slope Stability			38.777204 °	38.777204 °
				-121.687045 °	-121.687045 °
DWR ID	DWR_NA0022_01_s_2015_79				
Comment Code					
S2 : Repair the levee slope damaged by foot traffic and prevent access where possible.					
Inspector Comment					
Stairs have eroded and turned into a slope stability.

View of the stairs on the landward side of the levee looking downstream. Spring 2015.

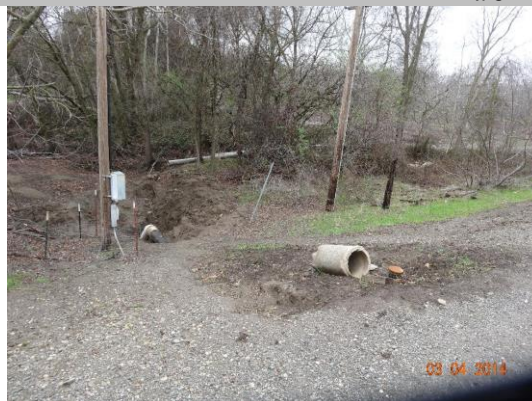
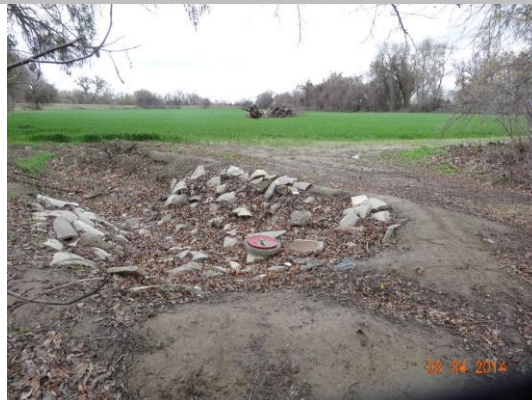
Comment Code					
Inspector Comment					
FS_ID:31917 DS_ID:19527 EP_NO: 3729 Repair Type: Non-Urgent Crossing Status: Found UCIP Comments: Crossing has been modified. Need to contact owner to determine additional information pertaining to the modifications. FIELD_STRUCT_DESC: 10-inch irrigation pipe through the levee, 3 feet below the crown. 1.5-inch conduit through the levee. 1-foot below the crown. Service pole and meter at toe of landward slope. Gate valve and pump on the waterward bank. Access ramp to pump location. Siphon breaker on the landward shoulder, in 12-inch concrete riser. Metal cutoff wall installed. (Permit No. 3729-1961).[Additional Reference(s): DWR Levee Log, 1990 and 2005]. FS Date: 3/4/2014

View of landward side, photo 1 of 2.

View of landward side, photo 2 of 2.

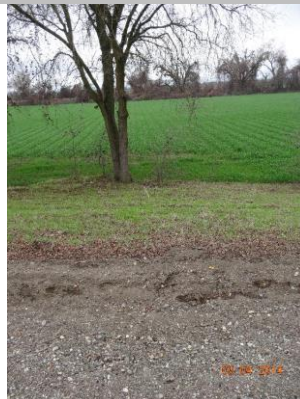
Photo 1 of 2 : UCIP\_FA\_2016\_38996\_69568.jpg

FS\_ID:38996  
DS\_ID:19528  
EP\_NO: 3722  
Repair Type: Non-Urgent  
Crossing Status: Found  
UCIP Comments: Pipe visible only on waterward side--Pipe needs to be properly abandoned per Title 23. Need to contact owner to determine status of crossing.  
FIELD\_STRUCT\_DESC: \*ABANDONED\* 10-inch steel pipe through the levee, 3 feet below the crown. 1.5-inch conduit 1 foot below the crown. Pump and gate valve on the waterside (WS) bank. Metal cutoff walls at centerline of levee. Siphon breaker is located on the landside (LS) shoulder in a 12-inch concrete riser. Pipe connects to existing 24-inch concrete standpipe at LS toe. (Permit No. 3722, 1961 - Traganza). No standpipe found on LS toe. In the 1955 DWR Levee Log the crossing was referenced as a 10-inch pipe at 5.3 feet below the crown at HLM 3.60. [Additional Reference(s): DWR Levee Log, 1955, 1990, and 2005].  
FS Date: 3/4/2014

View of landward side.

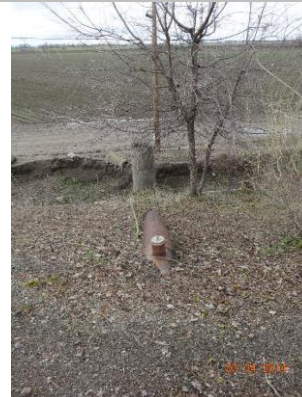
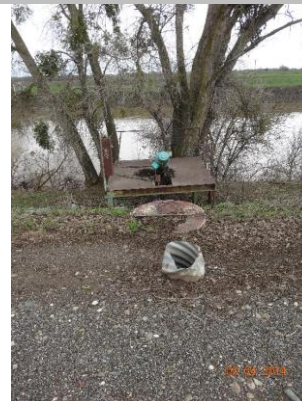
FS\_ID:38999  
DS\_ID:19529  
EP\_NO: 4570  
Repair Type: Non-Urgent  
Crossing Status: Found  
UCIP Comments: Need to contact owner to determine status of crossing. CMP riser damage on waterward slope.  
FIELD\_STRUCT\_DESC: 16-inch pipe through the levee, 5.0 feet below the crown. Metal plate welded on the waterside (WS) end. Pump, 1.5-inch conduit, and gate valve in concrete U-headwall are located on the WS bank, installed under Permit 7618A (1971). Pipe extends from pump to concrete standpipe on the landside (LS), pipe exposed on the LS slope. Water meter in 36-inch corrugated metal pipe (CMP) riser located on the WS slope. Siphon breaker on the LS shoulder, in 7-inch metal riser. 30-inch concrete riser at toe of LS slope. Metal cutoff wall installed. (Permit No. 4570, 1964 - England Brothers). [Additional Reference(s): DWR Levee Log, 1990 and 2005].  
FS Date: 3/4/2014

View of landward side.

View of waterward side.

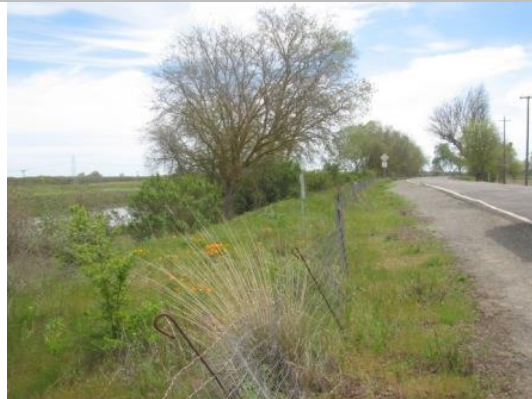
Photo 1 of 2 : FA\_2016\_NA0022\_350\_36\_20160913\_00032.jpg

LM Start	4.25	Rating **	A/W	Issue No.	36
LM End	4.49	Issue Type +	Ma	Location *	WS
Category	Earthen Levee			GPS Latitude/Longitude	
				Start	End
Item	Vegetation			38.767125 °	38.764582 °
				-121.693267 °	-121.690285 °
DWR ID	DWR_NA0022_01_s_2012_36				
Comment Code					
V8 : Environmental Requirements.					
Inspector Comment

Another view of the site.

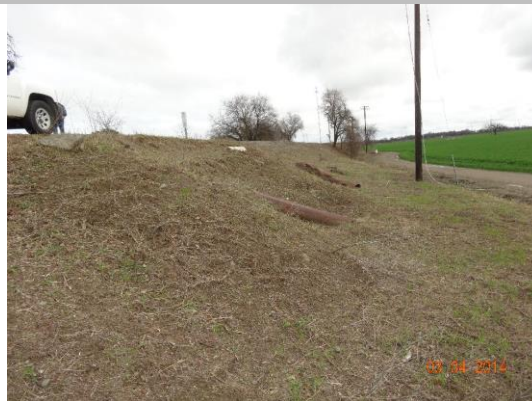
Photo 1 of 2 : UCIP\_FA\_2016\_31986\_58442.jpg

LM Start	4.44	Rating **	M	Issue No.	405
LM End	4.44	Issue Type +	En	Location *	LS
Category	Supplemental			GPS Latitude/Longitude	
				Start	End
Item	DWR UCIP Field Study			38.765142 °	38.765142 °
				-121.690963 °	-121.690963 °
DWR ID					
Comment Code					
Inspector Comment					
FS_ID:31986 DS_ID:19530 EP_NO: 9409 Repair Type: Non-Urgent Crossing Status: Found UCIP Comments: Pump station not found. Crossing appears to be abandon. Need to contact owner to determine status. Repair site on waterward side--waterward slope revegetated. FIELD_STRUCT_DESC: 16-inch steel pipe through the levee, 6.4 feet below the crown. Pump and control valve are located on the waterside (WS) bank. Ramp is located on landside (LS) slope. (Automatic Board Order (ABO) issued as Permit No. 9409, 1974 - Russell). [Additional Reference(s): DWR Levee Log, 1990 and 2005]. FS Date: 3/4/2014

View of landward side.

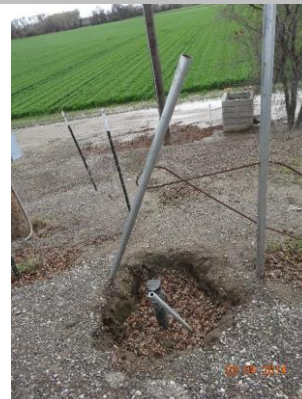
Photo 1 of 2 : UCIP\_FA\_2016\_49983\_69573.jpg

Comment Code					
Inspector Comment					
FS_ID:49983 DS_ID:19537 EP_NO: 18298 Repair Type: Urgent Crossing Status: Found UCIP Comments: 7/13/2016 same as last inspection - hole is still present near siphon breaker. Dense vegetation present and limits the inspector's visibility to identify signs of pipe failure (leaks) along the WS and LS slopes. Recommend removing vegetation along pipe alignment to conduct proper inspection of structure and appurtenances. (DWR UCIP - omagana)3/04/2014 Subsidence visible where siphon breaker is located on landward side. Unable to determine if subsidence is due to poor compaction or leak at siphon breaker. Need to contact owner to address issue. (DWR UCIP - omagana) FIELD_STRUCT_DESC: 14-inch steel water pipe through the levee, 2 feet below the levee crown. Pump platform is supported by 6 pilings located on the waterside (WS) slope. Siphon breaker and air release valve are located on the landside (LS) shoulder. Concrete distribution box is located on the LS toe. Rock riprap is used as armor along the WS slope. (Permit No. 18298, 2007 - Heidrick) FS Date: 7/13/2016

View of LS--subsidence near levee crown.

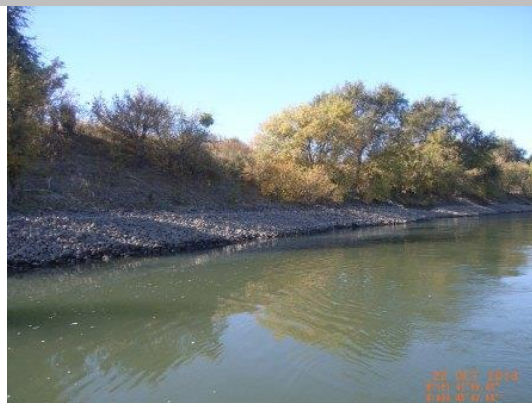
Photo 1 of 1 : FA\_2016\_NA0022\_350\_3\_20160913\_00002.jpg

LM Start	4.66	Rating **	M	Issue No.	3
LM End	4.86	Issue Type +	Ma	Location *	WS
Category	Supplemental			GPS Latitude/Longitude	
				Start	End
Item	2015 USACE Erosion Survey, DRAFT			38.763486 °	38.763313 °
				-121.687567 °	-121.684038 °
DWR ID	DWR_NA0022_01_s_2016_3				
Comment Code					
Inspector Comment					
2009 - Erosion into the levee toe. Some cobbles have been dumped into the erosion pockets. 2010 - Old cobble site starting to unravel. 2012 - Slope continues to steepen and new animal holes. 2013 - Downstream cobble is unraveling. 2015: No observed changes. [2015 Site ID: SAC_85-4_R]

USACE 2013 Photo #1

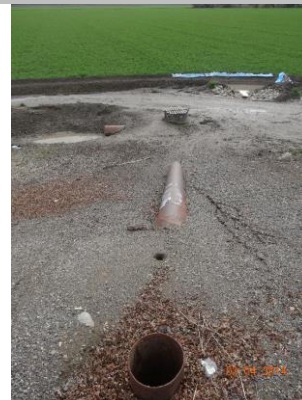
Photo 2 of 2 : UCIP\_FA\_2016\_49984\_58457.jpg

FS\_ID:49984  
DS\_ID:19531  
EP\_NO: 9408  
Repair Type: Urgent  
Crossing Status: Found  
UCIP Comments: 7/13/2016 Same as last inspeciton. Sink hole repair visible on levee road. Recommend contacting owner to determine if an internal integrity inspection of the pipe was completed to confirm sink hole was not the cause of the damage to road. If no internal integrity inspection was completed during road repair, recommend an internal integrity inspection be completed at this location based on the sink hole that developed along pipe alignment and based on age of pipe. (DWR UCIP - omagana)3/04/2014 Signs of sink hole repair on levee crown. Owner will need to contact CVFPB to address sink hole repair. (DWR UCIP - omagana)  
FIELD\_STRUCT\_DESC: 20-inch steel pipe through the levee, 4.7 feet below the crown. Two slant pumps located on the waterside (WS) slope. Two steel protective housing units are located on lanside (LS) shoulder and WS shoulder. Ramp is located on LS slope. (Automatic Board Order (ABO) issued as Permit No. 9408, 1974 - Davidella, Grace and Florence Hershey, Estates). [Additional Reference(s): DWR Levee Log, 1955, 1990, and 2005].

View of LS.

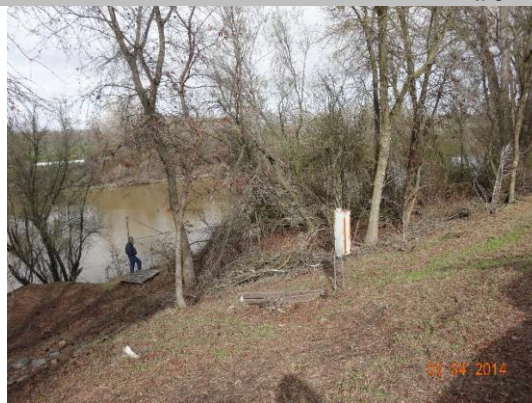
Photo 1 of 2 : UCIP\_FA\_2016\_31927\_58332.jpg

Comment Code					
Inspector Comment					
FS_ID:31927 DS_ID:19532 EP_NO: 3811 Repair Type: Non-Urgent Crossing Status: Found UCIP Comments: Unable to confirm is crossing is still in use. Need to contact owner to determine status of crossing. FIELD_STRUCT_DESC: 10-inch steel irrigation pipe through the levee, 3.6 feet below the crown. Pump is located at toe of waterside (WS) slope, on bank of river. Standard cutoff wall around pipe at center of levee. Standpipe is located at the toe of landside (LS) slope. Siphon breaker is located on the LS shoulder. This crossing replaces the previous USACE O&M irrigation pipe referenced at Station 27+49. (Permit No. 3811, 1962 - Inglin) [Additional Reference(s): DWR Levee Log, 1990 and 2005. USACE Sacramento O&M Manual Unit No. 127, June 1953, (Station 27+49)]. FS Date: 3/4/2014

View of waterward side.

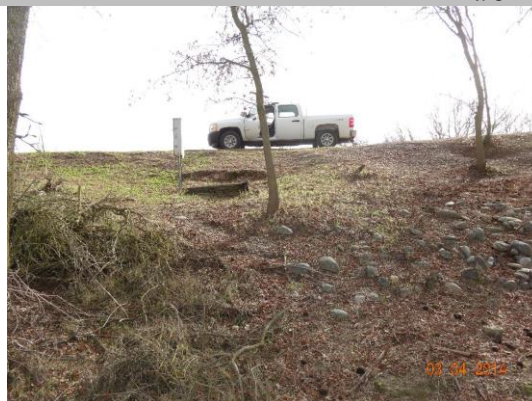
Photo 2 of 2 : UCIP\_FA\_2016\_31927\_58331.jpg

Rip rap along waterward slope.

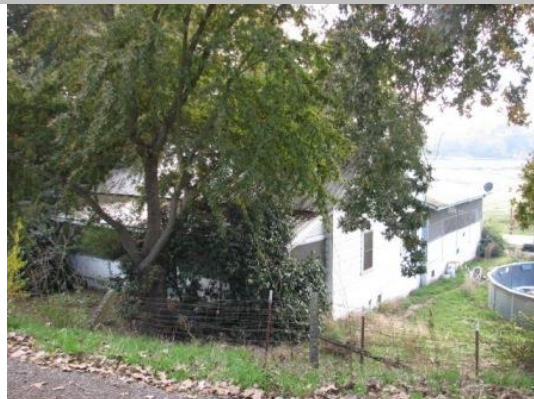
Photo 1 of 1 : FA\_2016\_NA0022\_350\_1\_20160913\_00001.jpg

LM Start	5.50	Rating **	M	Issue No.	1
LM End	5.54	Issue Type +	En	Location *	LS
Category	Earthen Levee			GPS Latitude/Longitude	
				Start	End
Item	Encroachments			38.759620 °	38.759412 °
				-121.673903 °	-121.673167 °
DWR ID	DWR_NA0022_01_s_2012_1				
Comment Code					
BU : Building					
Inspector Comment

The house and landscape are in the easement of the levee. Fall 2011

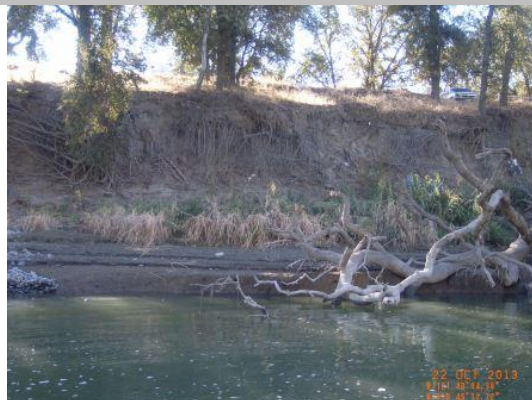
Photo 1 of 3 : FA\_2016\_NA0022\_350\_4\_20160913\_00003.jpg

LM Start	5.67	Rating **	M	Issue No.	4
LM End	5.85	Issue Type +	Ma	Location *	WS
Category	Supplemental			GPS Latitude/Longitude	
				Start	End
Item	2015 USACE Erosion Survey, DRAFT			38.759000 °	38.759390 °
				-121.670759 °	-121.667500 °
DWR ID	DWR_NA0022_01_s_2016_4				
Comment Code

USACE 2013 Photo #1

2006 - Approximately 18 to 20 ft of bank near levee at the corner of the levee and the Freemont Weir. Vertical bank with undercutting/mass failure. 2007 - Staked at top of bank for monitoring. 2011 - Site has become significantly worse with more of the toe and lower bank eroded. Many trees have fallen since last year. 2012 - Site looks worse with more erosion around trees. 2013 - Additional erosion into the toe. 2015: Site extended upstream about 500 ft to account for eroding bank. [2015 Site ID: SAC\_83-9\_R]

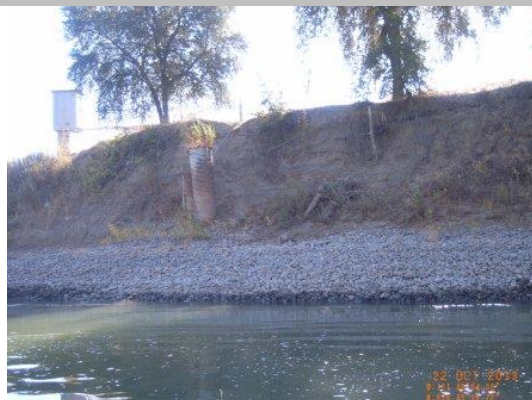
Photo 2 of 3 : FA\_2016\_NA0022\_350\_4\_20160913\_00004.jpg

LM Start	<b>5.67</b>	Rating **	M	Issue No.	<b>4 (cont)</b>
LM End	<b>5.85</b>	Issue Type +	Ma	Location *	WS

USACE 2013 Photo #2

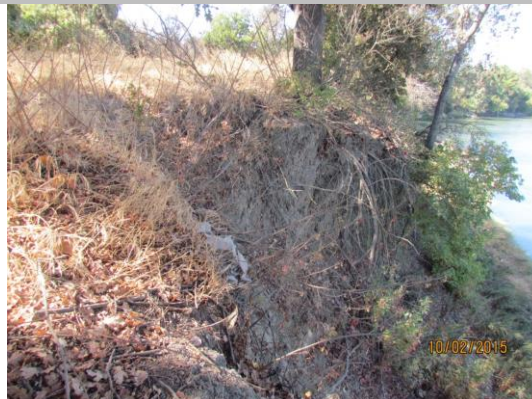
Photo 2 of 3 : FA\_2016\_NA0022\_350\_84\_20160913\_00058.jpg

LM Start	<b>5.83</b>	Rating **	U	Issue No.	<b>84 (cont)</b>
LM End	<b>5.83</b>	Issue Type +	Ob	Location *	WS

View of the erosion on the waterward side of the levee looking upstream. Fall 2015.
